PHOTOGRAPHIC SURVEY OF THE LDEF MISSION

NASA Special Publication 531

Robert L. O'Neal

Langley Research Center
Hampton, Virginia 23681-0001

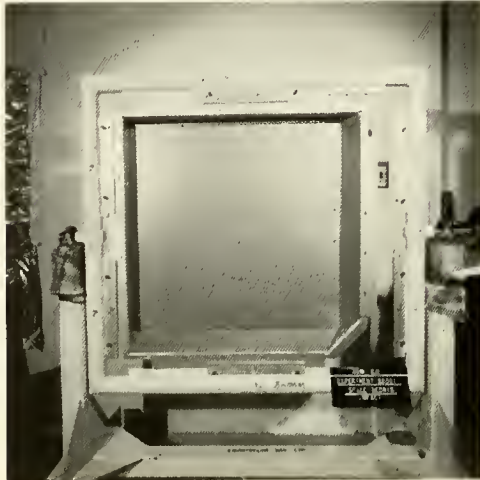
Figure 542 (Postflight). Irregular tan discolorations are visible on the lower experiment tray sidewall. The pink tint on the debris panel is a by-product of the chromic anodize coating process and is not attributed to contamination or exposure to the space environment. The light spots on the debris panel are the same abrasions that were observed in the in-flight photograph.

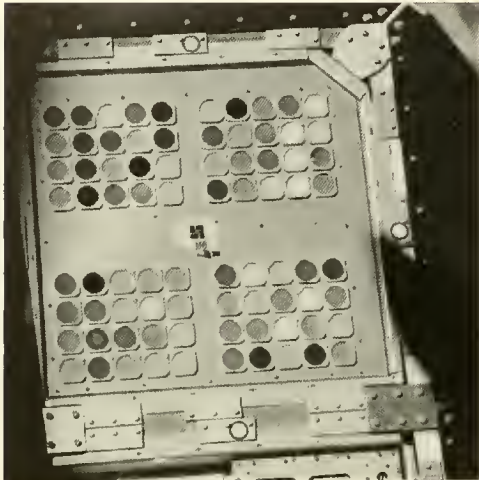
Figure 544
Photo No.: S32-76-050
Dup. Neg. No.: L90-10387
LISAR NO.: EL-1994-00667
Photo Credit: JSC
Photo Date: 1/12/90
Location: In Flight
Subject: In-Flight Survey of Tray G10

Figure 544 (In Flight). All experiment hardware seems to be in excellent condition and bond joints have maintained their integrity. The blue on the mirrorlike surface of the detectors is caused by reflections of the surroundings.

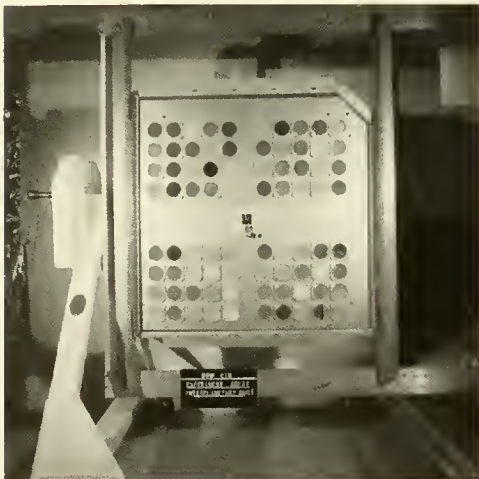
Figure 545
Photo No.: KSC-390C-2068.08
Dup. Neg. No.: L91-11688
LISAR NO.: EL-1994-00298
Photo Credit: KSC
Photo Date: 3/19/90
Location: KSC SAEF II
Subject: Postflight Survey of Tray G10

Figure 545 (Postflight). Experiment AO201 appears to have no visible degradation. The blue in the metallic surface of the detectors is caused by reflections of the surrounding area.

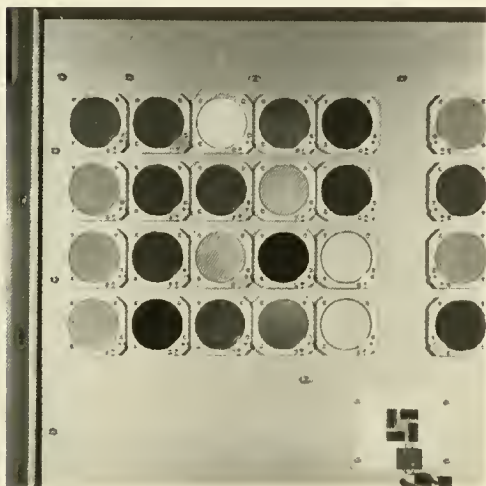
Figure 546
Photo No. KSC-390C-2068.09
Dup. Neg. No.: L91-11689
LISAR NO.: EL-1994-00468
Photo Credit: KSC
Photo Date: 3/19/90
Location: KSC SAEF II
Subject: Postflight Detail of Upper Left of Tray G10

Figure 546 (Postflight). This photograph is of the upper left one-fourth of the tray. The blue on the mirrorlike surface of the detectors is caused by reflections of the surroundings. Small impact craters are visible on some detectors. Surface scratches are also visible on the baseplate.

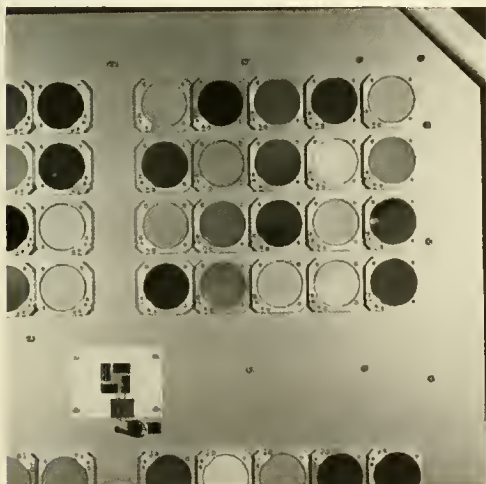
Figure 547
Photo No. KSC-390C-2068.10
Dup. Neg. No.: L91-11690
LISAR NO.: EL-1994-00469
Photo Credit: KSC
Photo Date: 3/19/90
Location: KSC SAEF II
Subject: Postflight Detail of Upper Right of
Tray G10

Figure 547 (Postflight). This photograph is of the upper right one-fourth of the tray. Small impact craters are visible on some detectors. The blue on the mirrorlike surface of the detectors is caused by reflections of the surroundings. Surface scratches are visible on the baseplate.

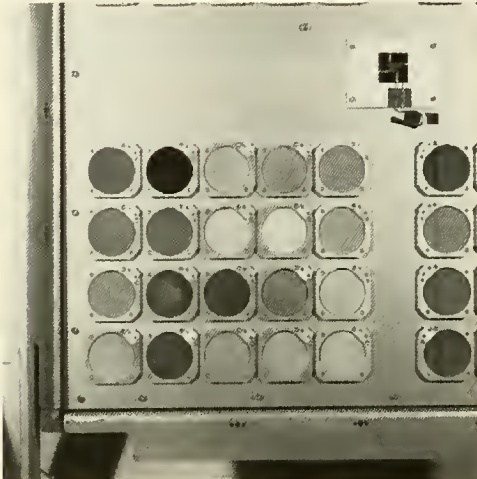
Figure 548 (Postflight). This photograph is of the lower left one-fourth of the tray. The blue on the mirrorlike surface of the detectors is caused by reflections of the surroundings. Small impact craters are visible on some detectors. Surface scratches are also visible on the baseplate. A pie-shaped discoloration is visible on the detector found second from the left and second from the bottom.

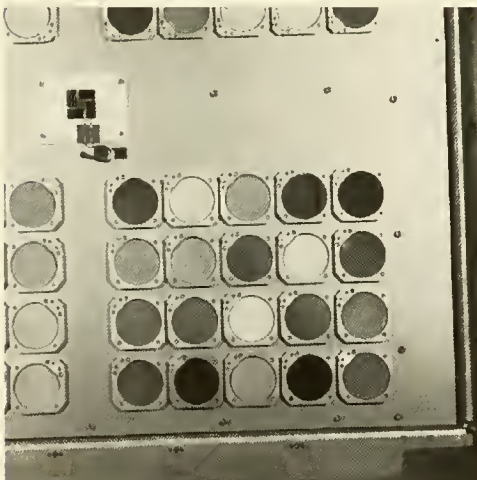
Figure 549 (Postflight). This photograph is of the lower right one-fourth of the tray. The blue on the mirrorlike surface of the detectors is caused by reflections of the surroundings. Small impact craters are visible on some detectors. Surface scratches are visible on the baseplate.

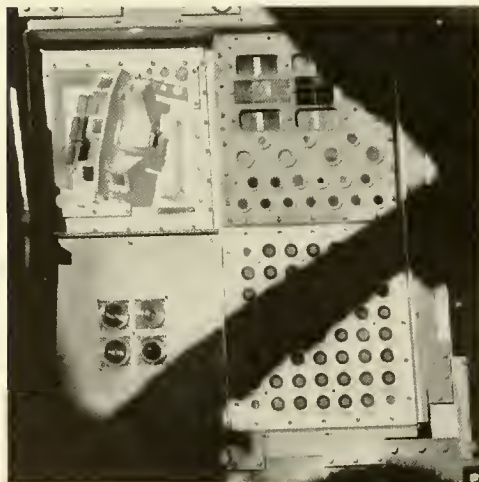
Figure 551
Photo No.: S32-76-054
Dup. Neg. No.: L90-10388
LISAR NO.: EL-1994-00668
Photo Credit: JSC
Photo Date: 1/12/90
Location: In Flight
Subject: In-Flight Survey of Tray G12

Figure 551 (In Flight). Shadows of the remote manipulator system cover a significant area of the picture. A light tan discoloration is visible on the baseplates and the mounting surfaces of the experiments. All experiment hardware appears intact.

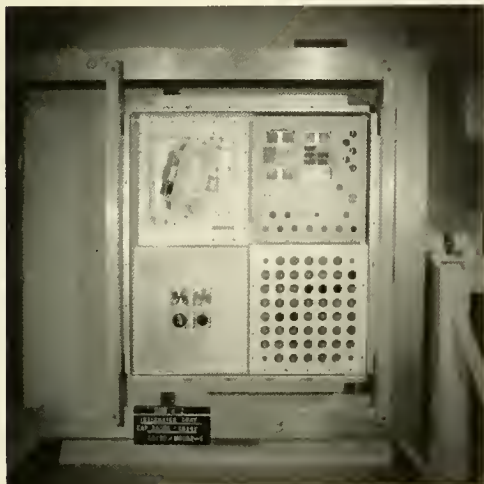
Figure 552
Photo No.: KSC-390C-1997.02
Dup. Neg. No.: L91-11718
LISAR NO.: EL-1994-00296
Photo Credit: KSC
Photo Date: 3/15/90
Location: KSC SAEF II
Subject: Postflight Survey of Tray G12

Figure 552 (Postflight). The experiment hardware appears intact. There are areas of discoloration on the baseplates and mounting structure of the experiments. The cover plate of experiment AO147 in the lower left, which was originally painted with Chemglaze II A276, now has a light tan discoloration over most of the surface area.

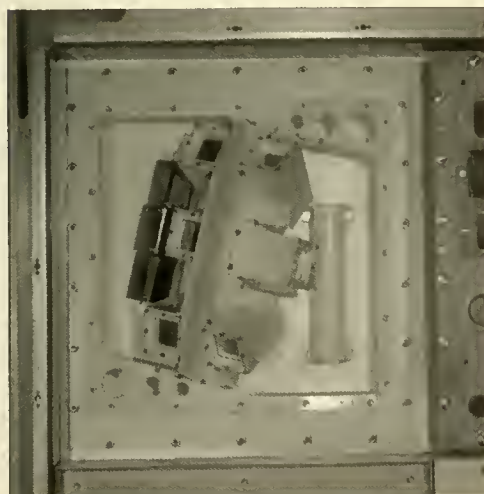
Figure 553
Photo No.: KSC-390C-1997.03
Dup. Neg. No.: L91-11719
LISAR NO.: EL-1994-00442
Photo Credit: KSC
Photo Date: 3/15/90
Location: KSC SAEF II
Subject: Postflight Detail of Upper Left of Tray G12

Figure 553 (Postflight). This photograph is of the upper left one-fourth of the tray. Experiment M0002-1 has a brown discoloration that is concentrated more heavily on areas that are away from the base. The hardware and sensors are intact.

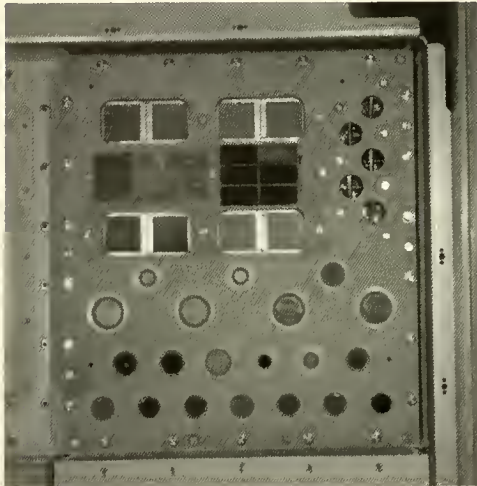
Figure 554 (Postflight). This photograph is of the upper right one-fourth of the tray. The faceplate of experiment AO056, which is painted with Chemglaze II A276 white paint, is much darker than in the preflight photograph. The discoloration is not uniform.

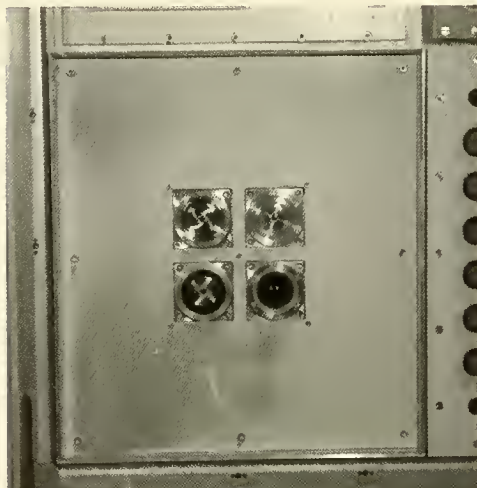
Figure 555 (Postflight). This photograph is of the lower left one-fourth of the tray. The faceplate of experiment AO147, which was painted with Chemglaze II A276, has areas of brown discoloration that are concentrated more on the left side. Note the discoloration flow pattern below the fasteners. The sensors are intact.

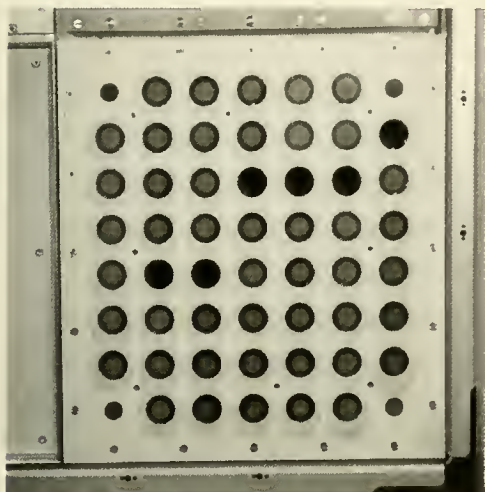
Figure 556 (Postflight). This photograph is of the lower right one-fourth of the tray. The faceplate that was painted with Chemglaze II A276 white paint is slightly less white than in preflight. There are brown discoloration flow patterns below some of the sample holders. The test samples are intact.

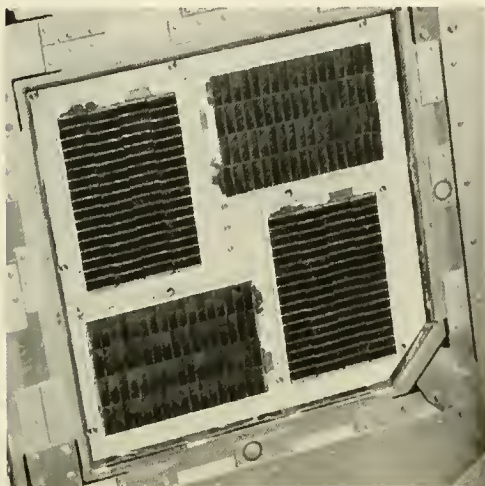
Figure 558 (In Flight). The white paint dots on the center clamp blocks of the right flange and lower flange of the experiment tray are discolored. The discoloration diminishes as the distance from the vent area of the thermal panels increases. The right and lower tray flanges near the vents also are discolored. Fingerprints are visible on the thermal panels in the vicinity of the panel mounting fasteners. The experiment hardware appears to be intact with no apparent changes other than stains along outer edges of the solar arrays.

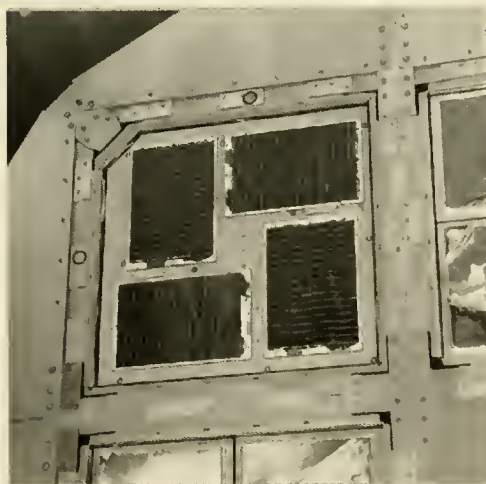
Figure 559 (Postflight). This photograph of experiment S1001 was taken from the cargo bay access hatch of the orbiter during postlanding operations at Dryden Flight Research Center. Note the discolorations on the structure of the LDEF, tray flanges, and tray clamp white dots. Note also the variation of discoloration with proximity to the thermal panel vents. Fingerprints are visible on the thermal panels in the vicinity of the panel mounting fasteners. The experiment hardware is intact with no apparent changes other than stains along outer edges of the solar arrays. The atomic oxygen samples in the upper left corner of the tray appear to be degraded. The Kapton tape is loose on the sample in the lower right corner of the tray and on the center sample on the upper tray flange. In other areas, the tape appears to be firmly adhered to the tray flanges.

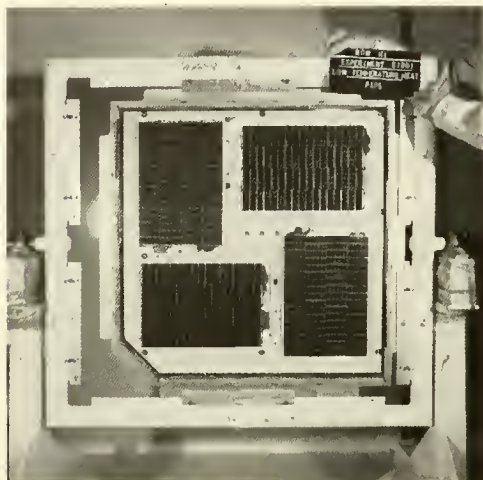
Figure 560 (Postflight). The experiment hardware is intact with no apparent changes other than stains along outer edges of the solar arrays. The light brown stains observed along the upper edges of the solar array mounting plates and around the outer edge of the baseplate in the in-flight photograph are not apparent in this postflight photograph.

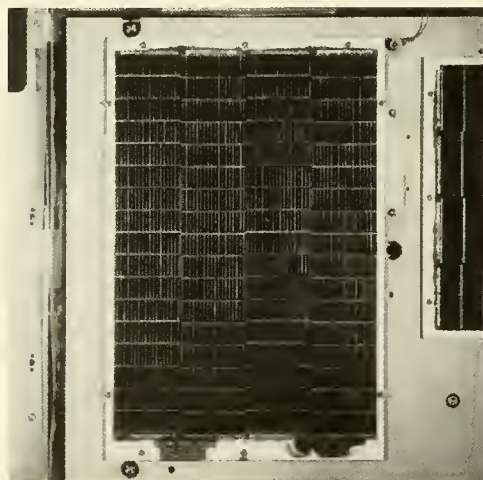
Figure 561 (Postflight). This photograph is of the upper left one-fourth of the tray. The solar cells appear intact. A few small impact craters on the array are visible. The atomic oxygen experiment samples that were attached to the tray flanges with Kapton tape are in place.

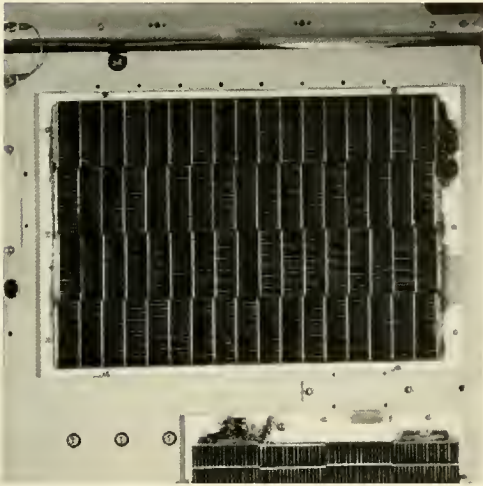
Figure 562 (Postflight). This photograph is of the upper right one-fourth of the tray. The solar cells appear intact. A few small impact craters on the array are visible. The Kapton tape that is holding atomic oxygen experiment samples to the tray flange is loose.

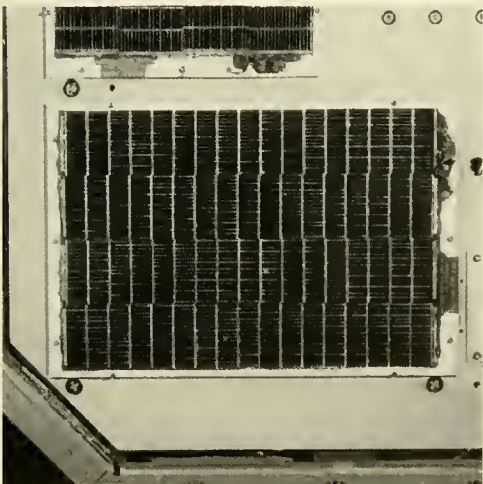
Figure 563 (Postflight). This photograph is of the lower left one-fourth of the tray. The solar cells appear intact. A few small impact craters on the array are visible. The atomic oxygen experiment samples on the left and in the center that were attached to the tray flanges with Kapton tape are damaged.

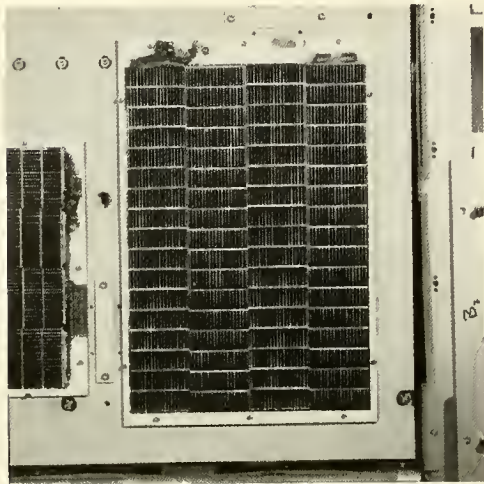
Figure 564 (Postflight). This photograph is of the lower right one-fourth of the tray. The solar cells appear intact. A few small impact craters on the array are visible. The atomic oxygen experiment samples attached to the tray flanges with Kapton tape are in place.

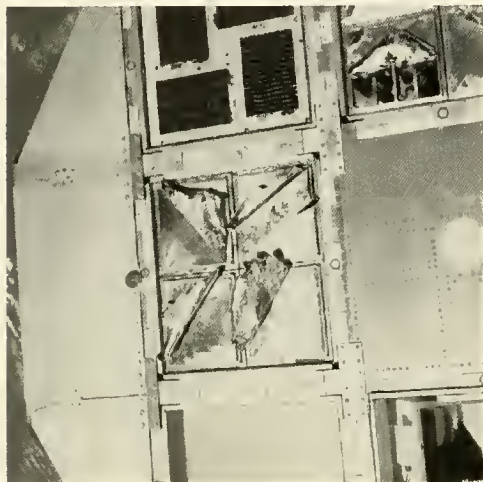
Figure 566 (In Flight). A light tan stain is visible on the end structure along the left edge of the tray flange. Lighter stains are also visible on the tray flange between the top and the center tray clamp blocks on the left side. The multilayer thermal insulation blanket has extensive damage. The tape joints have failed along two sides of each experiment module and have allowed the thermal blanket to curl back over itself. The gold-colored surfaces that have then been exposed are the top sheet of the Lexan detector stacks that are held securely in place by the Z shaped aluminum structure.

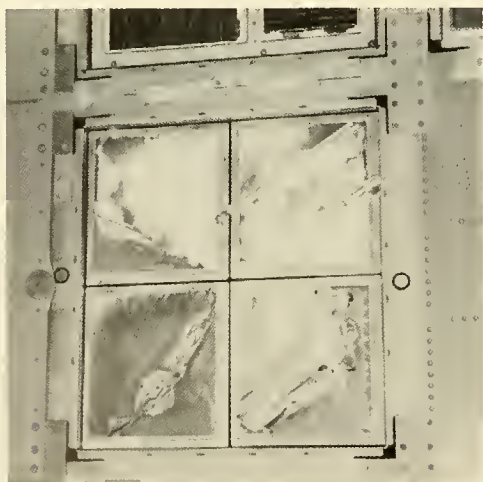
Figure 567 (Postflight). This photograph, which was taken from the cargo bay access hatch of the orbiter during postlanding operations at the Dryden Flight Research Center, shows extensive damage to the multilayer thermal insulation blanket. The tape joints appear to have failed along two sides of each experiment module and allowed the multilayer thermal insulation blanket to curl back over itself. The curls are now tighter than they were in flight. Note the discolorations on the structure of the LDEF, tray flanges, and tray clamp white dots and the variation of discoloration with proximity to the thermal panel vents. The paint on the top layer of the thermal blankets, which was originally white, now appears brown or light tan. The fragments of aluminum in the lower two quadrants appear to be from the delamination of the vapor-deposited aluminum from the thermal insulation blanket.

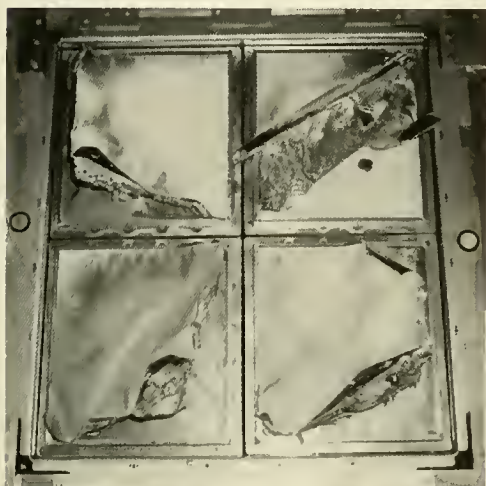
Figure 568 (Postflight). This photograph shows the four experiment modules with the thermal blankets severely degraded. The paint on the top layer of the thermal blanket, previously white, is now a glossy tan or soft brown. The tape that was used to attach the thermal blanket to the module frames failed during flight. The tape failed in tension because of thermal shrinkage of the blankets, thus leaving tape on both the frame and the top layer of the thermal blanket. The material exposed underneath the thermal blanket is the top sheet of the detector stack. A Dacron mesh (bridal veil) separator is clearly visible in the upper right module. The coating of vapor-deposited aluminum has delaminated from the Mylar film and the Mylar film has eroded. The delaminated aluminum extends from the blanket in the lower right module. The loss of the Dacron mesh and some of the aluminum delamination is thought to have occurred prior to retrieval; however, a significant portion of the aluminum delamination from the Mylar is thought to have occurred postlanding because of the velocity and direction of air from the cargo bay purge system.

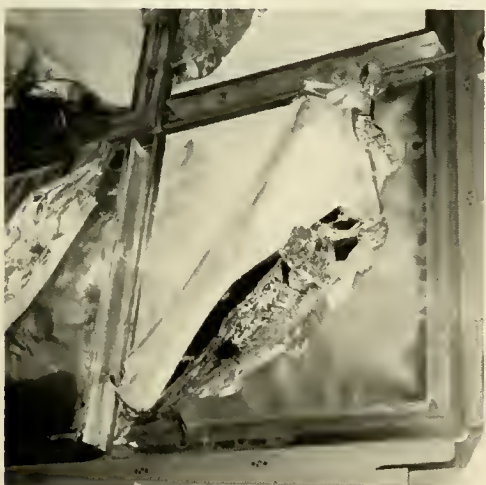
Figure 569 (Postflight). This photograph of the lower right module shows the discolorations and the extensive damage to the thermal blanket.

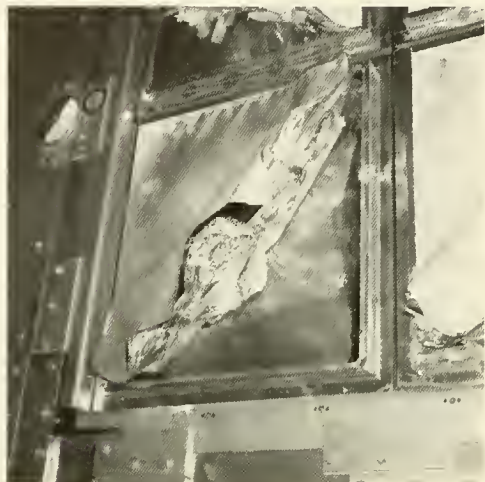
Figure 570 (Postflight). This photograph of the lower left module shows the discolorations and the extensive damage to the thermal blanket.

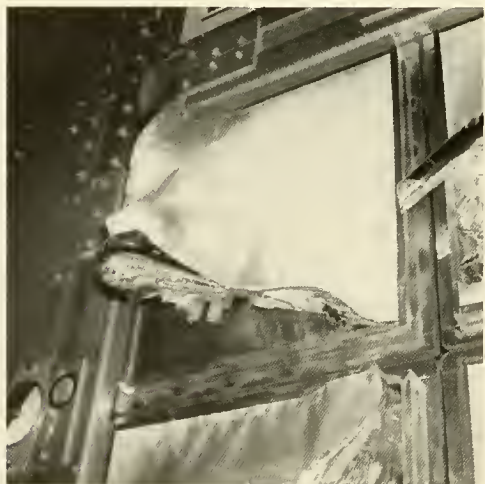
Figure 571 (Postflight). This photograph of the upper left module shows the discolorations and the extensive damage to the thermal blanket.

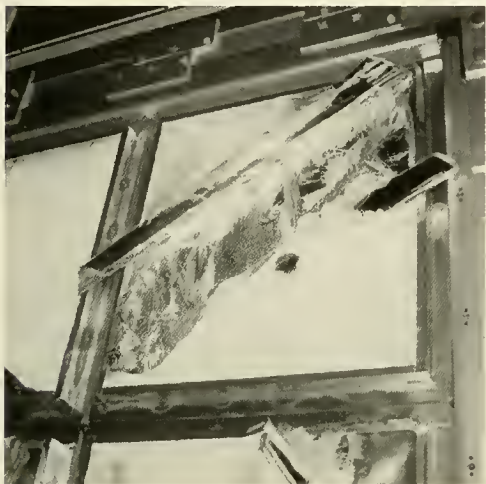
Figure 572 (Postflight). This photograph of the upper right module shows the discolorations and the extensive damage to the thermal blanket.

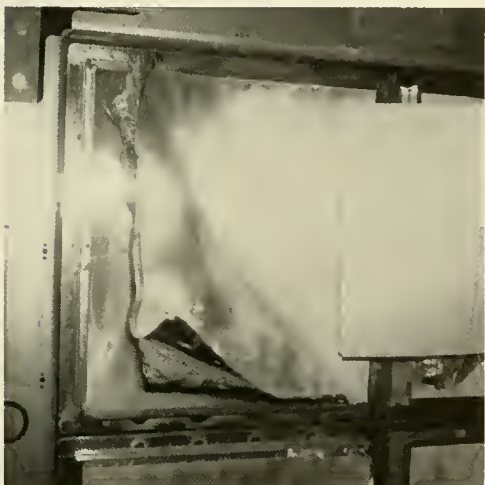
Figure 573 (Postflight). This photograph of the upper left module shows the discolorations and the extensive damage to the thermal blanket. A white reference card is also shown in the photograph.

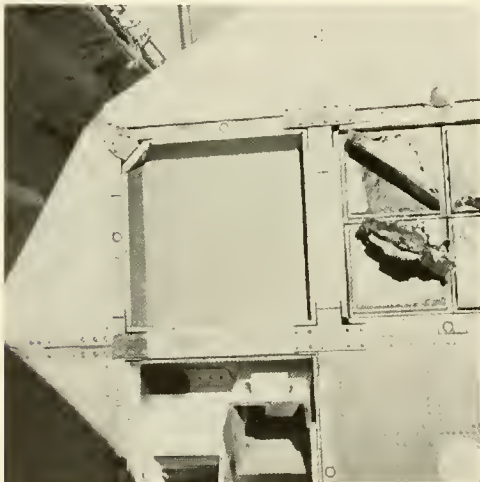
Figure 574 (In Flight). The paint dots on the experiment tray clamp blocks, which were originally white, show a tan stain that gets darker near the venting area of the end thermal panels. The stain also covers the top and left flanges of the experiment tray. To a lesser degree, the lower and right tray flanges are also covered with the stain. The vertical lines and the pinkish color of the debris panel are chromic anodize coating by-products and are not attributed to contamination or exposure to the space environment.

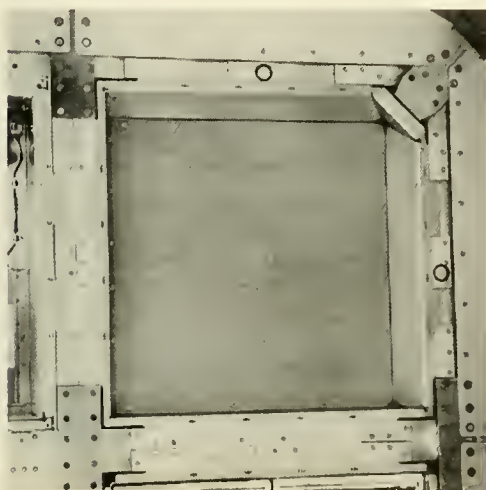
Figure 575 (Postflight). This photograph was taken from the cargo bay access hatch of the orbiter during postlanding operations at the Dryden Flight Research Center. Note the discolorations on the structure of the LDEF, tray flanges, and tray clamp white dots and the variation with proximity to the thermal panel vents. The discolorations on the tray sidewalls appear to be fingerprints enhanced by the brown stain. Light discolorations are located near the lower side of the debris panel. The horizontal lines and the pinkish tint of the debris panel are chromic anodize coating by-products and are not attributed to contamination or exposure to the space environment. Darker discolorations on the debris panel, similar to water marks, are apparent in the photograph.

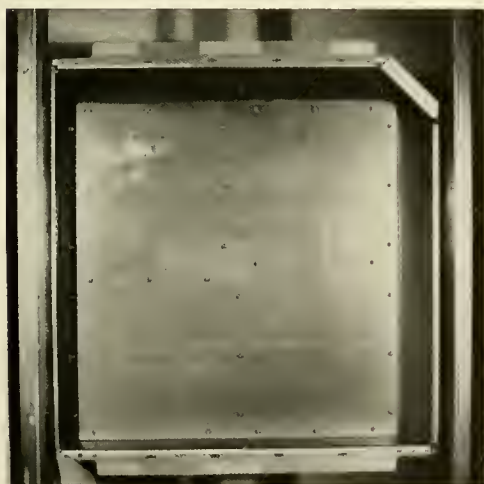
Figure 576 (Postflight). A brown discoloration is visible on the lower tray flange and a lighter discoloration is visible on the upper tray flange that is not covered by the experiment tray clamp blocks. Irregular tan discolorations are also visible on the experiment tray lower sidewall with a darker stain in the left tray corners.

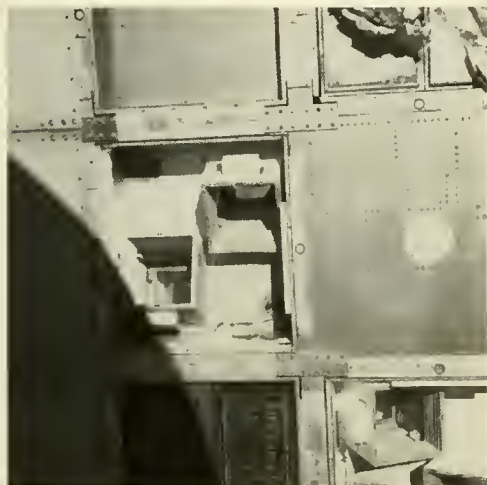
Figure 578 (In Flight). A shadow of the shuttle obscures part of the tray. A very light contamination stain is present on the experiment tray flanges and on most of the visible structure. An exception is a much darker stain on the structure adjacent to thermal panels that provided venting for the interior of the LDEF. The white thermal control paint now varies from off-white to a dark brown. Localized dark brown areas in the tray are visible. A beryllium copper collector foil is clearly visible in the lower left canister housing as are the baffles. Light from the fine wire mesh grid is reflected near the top of the canister housing. Because of an experiment system malfunction, the canister collector foils that are visible were exposed for the total mission.

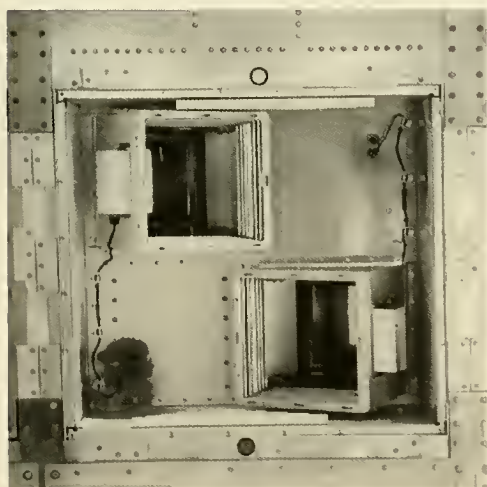
Figure 579 (Postflight). This photograph was taken from the cargo bay access hatch of the orbiter during postlanding operations at the Dryden Flight Research Center. Note the discolorations on the structure of the LDEF, tray flanges, and tray clamp white dots and the variation of discoloration with proximity to the thermal panel vents. The darker appearance of the tray interior is probably due to lighting. A beryllium copper collector foil is clearly visible within the canister housings as are the baffles. Reflected light from the fine wire mesh grid is visible near the top of the canister housing.

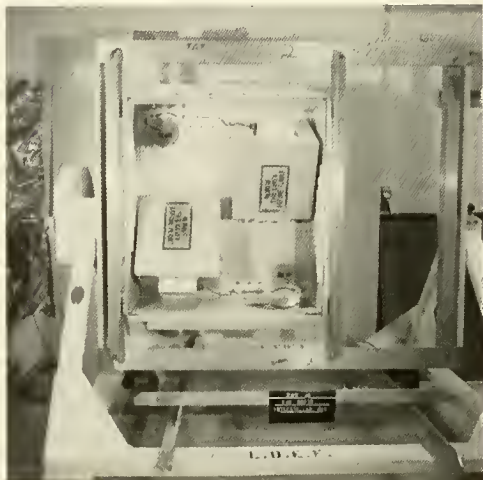
Figure 580
Photo No.: KSC-390C-1641.03
Dup. Neg. No.: L91-11828
LISAR NO.: EL-1994-00215
Photo Credit: KSC
Photo Date: 3/6/90
Location: KSC SAEF II
Subject: Postflight Survey of Tray H6

Figure 580 (Postflight). The brown stains are still very prominent and appear to be the same as in the in-flight photograph. The covers have been installed on the canister housings to protect the space-exposed hardware. The contamination stain shows an outline of tray clamp-block locations on the experiment tray flanges.

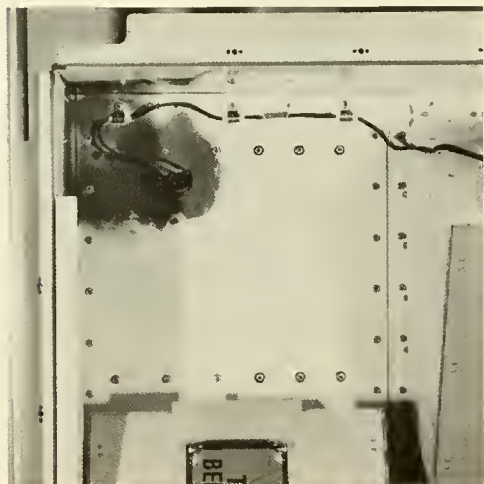
Figure 581
Photo No.: KSC-390C-1641.04
Dup. Neg. No.: L91-11829
LISAR NO.: EL-1994-00051
Photo Credit: KSC
Photo Date: 3/6/90
Location: KSC SAEF II
Subject: Postflight Detail of Upper Left of Tray H6

Figure 581 (Postflight). This photograph is of the upper left one-fourth of the tray. Note the extreme dark brown discoloration around the grid voltage plug in the corner of the tray.

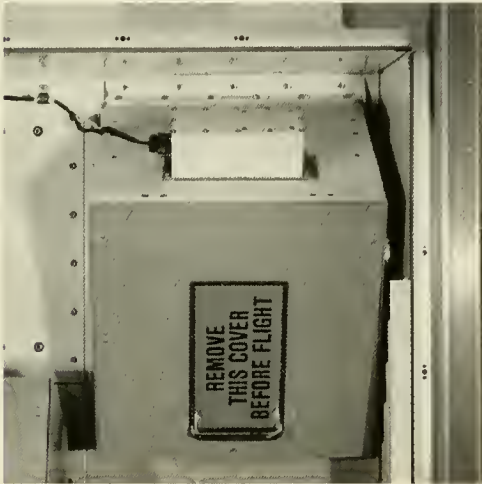
Figure 582 (Postflight). This photograph is of the upper right one-fourth of the tray. Some dark contamination is visible below the canister. Some shadows are caused by photographic lighting. The cover has been installed on the canister housing to protect the space-exposed hardware.

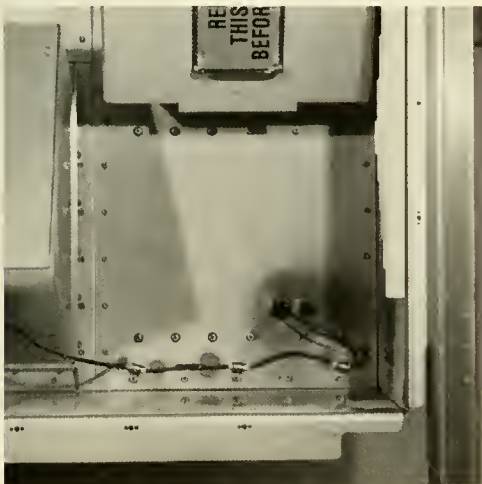
Figure 583 (Postflight). This photograph is of the lower right one-fourth of the tray. Note the extreme brown discoloration around the grid voltage leads and plug. The cover has been installed on the canister housing to protect the space-exposed hardware.

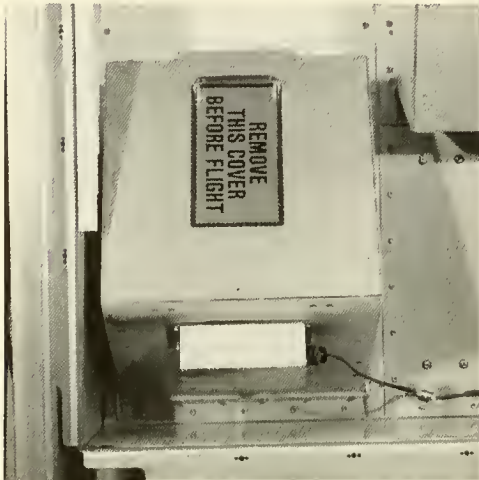
Figure 584 (Postflight). This photograph is of the lower left one-fourth of the tray. Note the extreme brown discoloration on tray and canister sides. The cover has been installed on the canister housing to protect the space-exposed hardware.

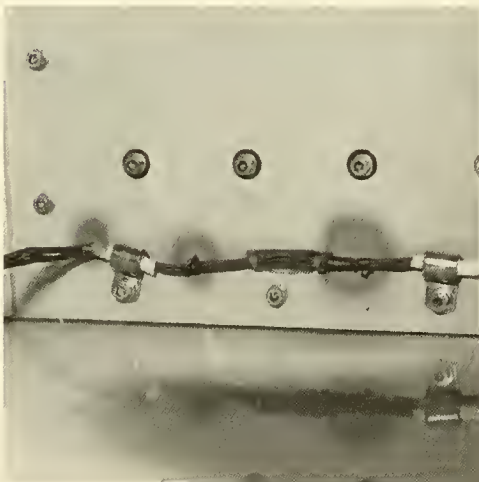
Figure 585 (Postflight). This close-up photograph is of the lower right corner of the tray. Note the localized extreme brown discoloration around the electrical cable wraps. There is a reflection of the cable in the tray sidewall.

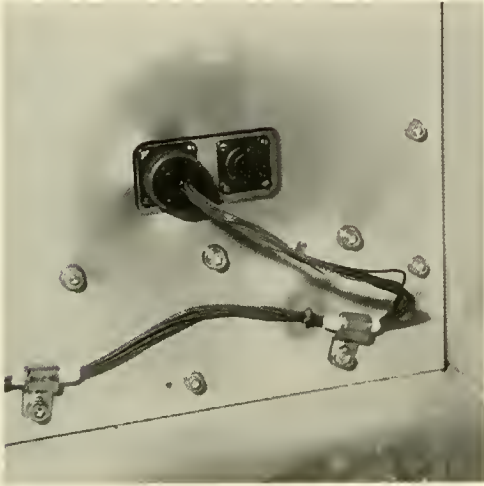
Figure 586 (Postflight). This close-up photograph is of the lower right corner of the tray. Note the brown discoloration around the grid voltage plug and around the cable wraps.

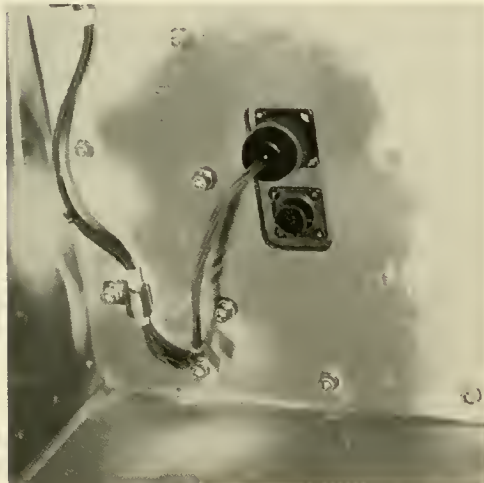
Figure 587 (Postflight). This close-up photograph is of the upper left corner of the tray. Note the extreme brown discoloration patterns. There is a distinct pattern of the grid voltage cable on the tray side wall.

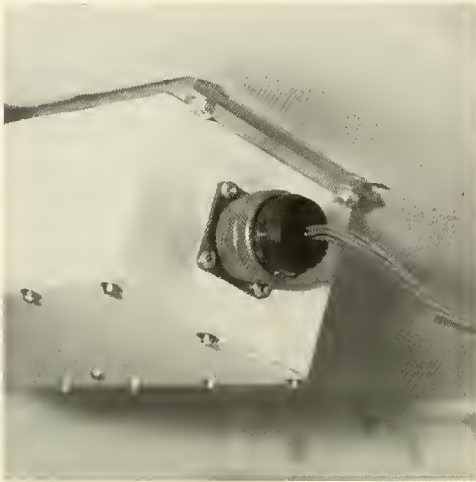
Figure 588 (Postflight). This close-up photograph is of the lower canister. There is a discoloration or shielding pattern around the grid voltage plug.

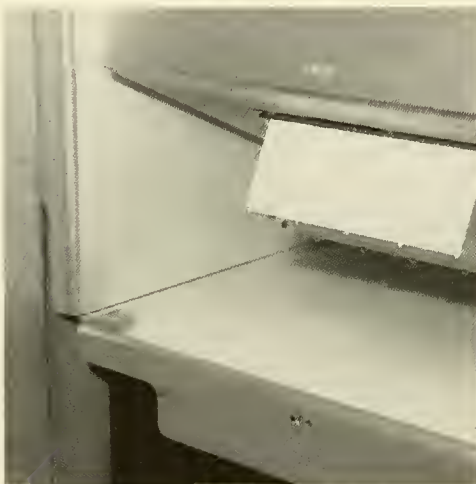
Figure 589 (Postflight). This close-up photograph is of the lower left corner of the tray. Note the brown discoloration on the left wall of the tray.

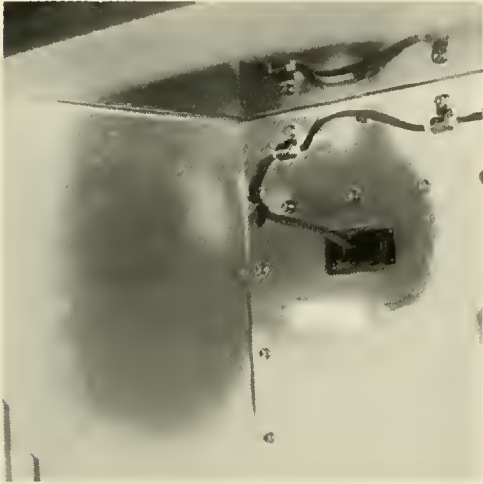
Figure 590 (Postflight). This close-up photograph is of the upper left corner of the tray. Note the extreme brown discoloration. There is a photographic light reflection just below the grid voltage plug. There is also a reflection of the electrical cable in the tray sidewall.

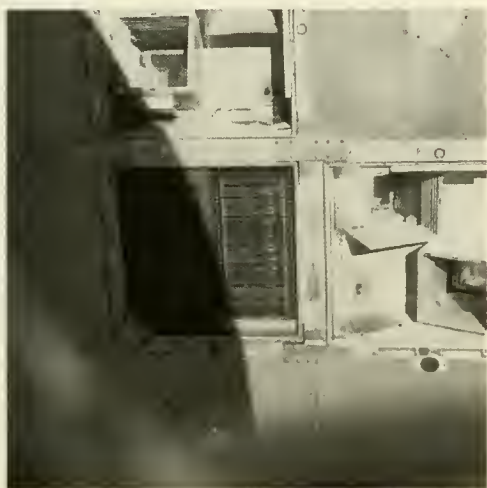
Figure 592
Photo No. S32-75-062
Dup. Neg. No.: L90-10368
LISAR NO.: EL-1994-00673
Photo Credit: JSC
Photo Date: 1/12/90
Location: In Flight
Subject: In-Flight Survey of Tray H7

Figure 592 (In Flight). A shadow cast by the orbiter covers most of the left half of the tray, which contains the active part of the experiment. The experiment appears to be without physical damage. Even in the shadow, a light tan discoloration is visible on the left and lower flanges of the experiment tray. A darker stain has discolored the originally white paint dots on the experiment tray clamp blocks. Dark brown stains on the structure of the LDEF are visible in areas adjacent to the edge of thermal end panels that were designed to facilitate venting of the interior.

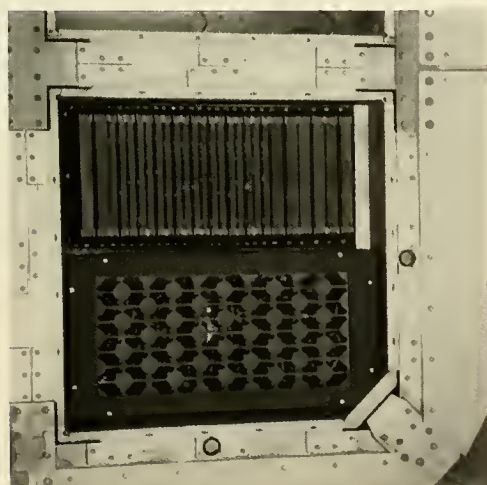
Figure 593
Photo No.: S32(S)-288
Dup. Neg. No.: L92-21195
LISAR NO.: EL-1994-00075
Photo Credit: JSC
Photo Date: 1/22/90
Location: Shuttle Cargo Bay at Dryden
Subject: Postflight Survey of Tray H7

Figure 593 (Postflight). The experiment appears to have no physical damage. This photograph was taken from the cargo bay access hatch of the orbiter during postlanding operations at the Dryden Flight Research Center. Note the discolorations on the structure of the LDEF, the tray flanges, and the tray clamp white dots and the variation of discoloration with proximity to the thermal panel vents. The black thermal coating on the passive part of the experiment appears unchanged, while the black thermal coating on the active part of the experiment appears dark gray. The surfaces of the Kapton film specimens of the passive experiment appear to have changed from specular to diffuse after exposure to the space environment.

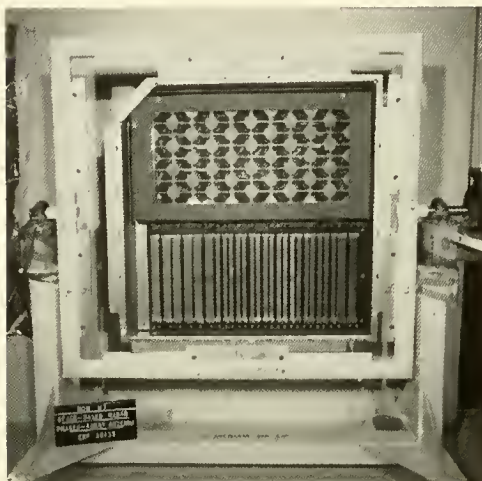
Figure 594 (Postflight). Experiment AO133 appears to have no physical damage. A light tan discoloration is visible on the left and lower flanges of the experiment tray and also on the unpainted aluminum filler to the left of the passive part of the experiment. A darker stain has discolored the lower corners of the tray structure. The black thermal coating on the active part of the experiment has changed from flat black to dark gray. The coating on the passive part of the experiment appears less degraded. The exposed surfaces of the Kapton film specimens in both the active and passive parts of the experiment appear to have changed from specular to diffuse because of exposure to the space environment.

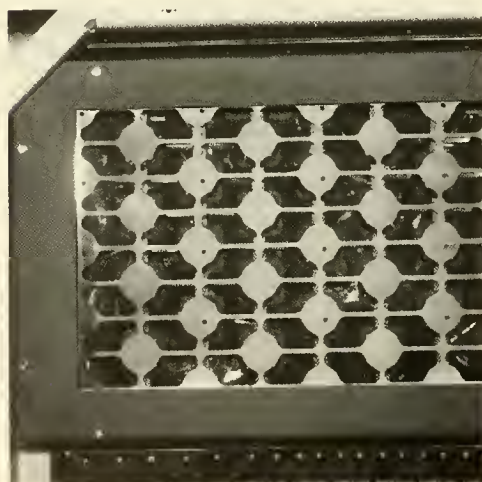
Figure 595 (Postflight). This photograph is of the upper left one-fourth of the tray. The experiment is intact, but the surface appears lighter than in preflight conditions. Light reflections from some underlying surfaces are visible.

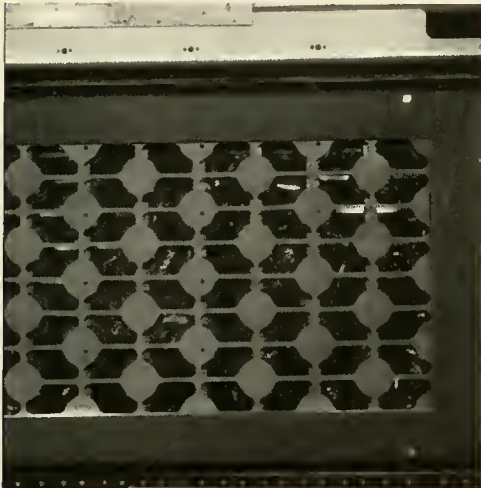
Figure 596 (Postflight). This photograph is of the upper right one-fourth of the tray. The experiment is intact, but the surface appears lighter than in preflight conditions. Light reflections from some underlying surfaces are visible.

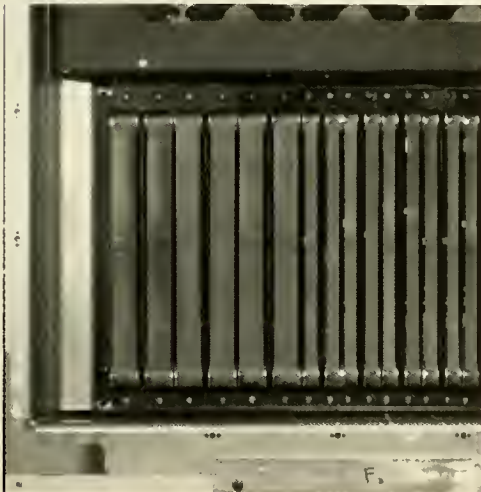
Figure 597 (Postflight). This photograph is of the lower left one-fourth of the tray. The experiment is intact. The color of the test specimens does not appear as dark as in preflight.

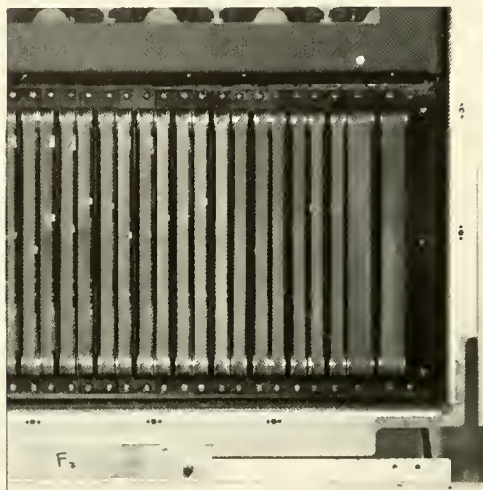
Figure 598 (Postflight). This photograph is of the lower right one-fourth of the tray. The experiment is intact, but the test specimens are not as dark as in preflight. Light reflections from some underlying surfaces are visible.

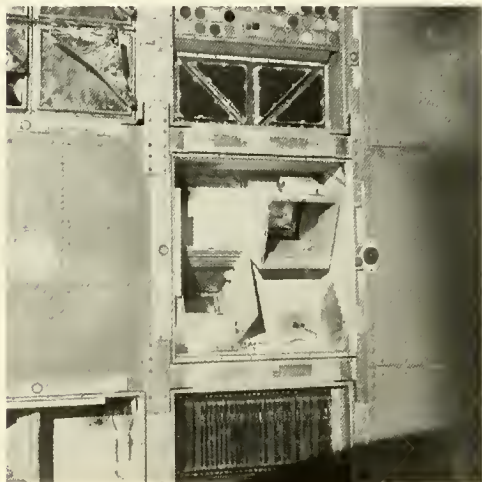
Figure 600
Photo No.: S32-75-061
Dup. Neg. No.: L90-10367
LISAR NO.: EL-1994-00672
Photo Credit: JSC
Photo Date: 1/12/90
Location: In Flight
Subject: In-Flight View of Tray H9

Figure 600 (In Flight). A very light contamination stain is present on the experiment tray flanges and on most of the visible structure of the LDEF. The exception is a darker stain on the structure adjacent to thermal panels that provided venting for the interior. Both paint dots are heavily coated with the brown contamination stain. The color of the white thermal control paint now varies from off-white to dark brown with areas of concentrated brown discoloration. A beryllium copper collector foil is clearly visible in the lower left canister housing as are the baffles. Reflected light from the fine wire mesh grid is visible near the top of the canister housing. Because of an experiment system malfunction, the canister collector foils that are visible were exposed for the total mission.

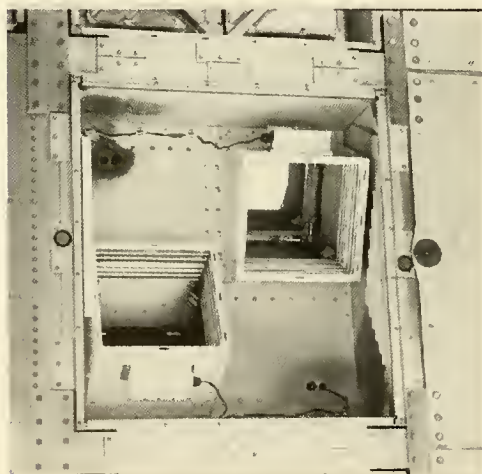
Figure 601
Photo No.: S32(S)-286
Dup. Neg. No.: L92-21193
LISAR NO.: EL-1994-00074
Photo Credit: JSC
Photo Date: 1/22/90
Location: Shuttle Cargo Bay at Dryden
Subject: Postflight Survey of Tray H9

Figure 601 (Postflight). This photograph was taken from the cargo bay access hatch of the orbiter during postlanding operations at the Dryden Flight Research Center. Note the discolorations on the structure of the LDEF, tray flanges, and tray clamp white dots and the variation of discoloration with proximity to the thermal panel vents. The color of the white thermal control paint now varies from off-white to dark brown with areas of concentrated discoloration. A beryllium copper collector foil is clearly visible in the upper right canister housing as are the baffles. Reflected light from the fine wire mesh grid is visible near the top of the canister housing.

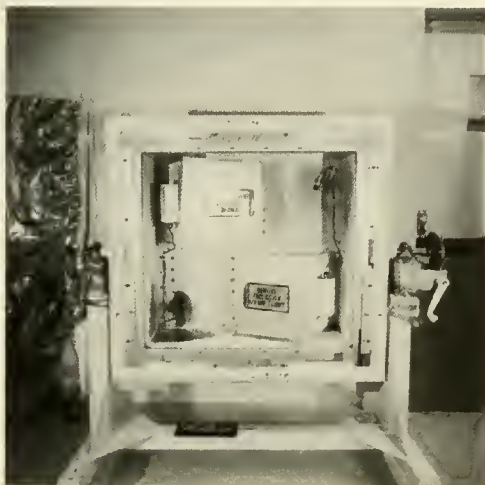
Figure 602
Photo No.: KSC-390C-1636.10
Dup. Neg. No.: L91-11881
LISAR NO.: EL-1994-00214
Photo Credit: KSC
Photo Date: 3/6/90
Location: KSC SAEF II
Subject: Postflight Survey of Tray H9

Figure 602 (Postflight). The brown stains are still very prominent and appear to be the same as in the in-flight photograph. The openings in the baseplate for the grid voltage cable connector mounts are thought to be the source of the darker brown stains around the connectors. The covers were installed on the canister housings to protect the space-exposed hardware. The contamination stain provides an outline of tray clamp block locations on the tray flanges.

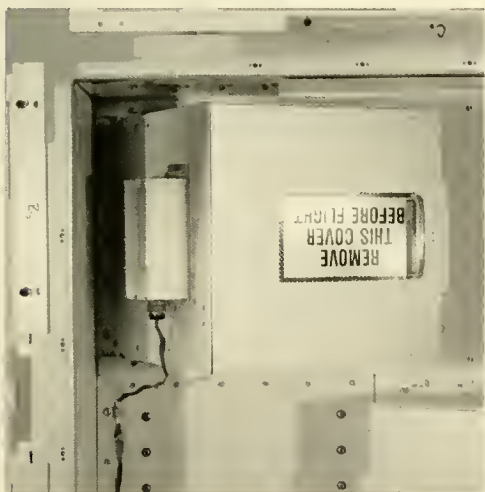
Figure 603
Photo No.: KSC-390C-1637.01
Dup. Neg. No.: L91-11912
LISAR NO.: EL-1994-00656
Photo Credit: KSC
Photo Date: 3/6/90
Location: KSC SAEF II
Subject: Postflight Detail of Upper Left of Tray H9

Figure 603 (Postflight). This photograph is of the upper left one-fourth of the tray. Note the discoloration on the tray around the canister. The cover was installed on the canister housing to protect the space-exposed hardware.

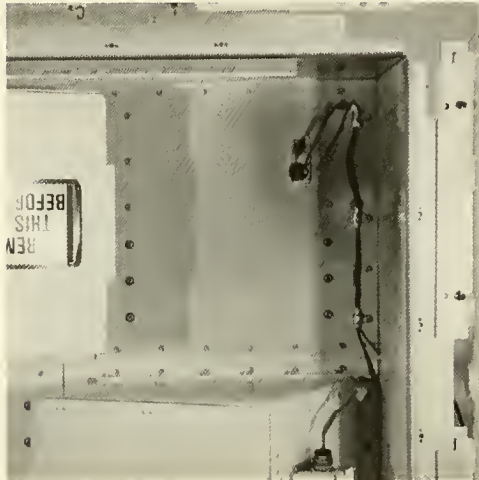
Figure 604
Photo No.: KSC-390C-1637.02
Dup. Neg. No.: L91-I1913
LISAR NO.: EL-1994-00695
Photo Credit: KSC
Photo Date: 3/6/90
Location: KSC SAEF II
Subject: Postflight Detail of Upper Right of Tray H9

Figure 604 (Postflight). This photograph is of the upper right one-fourth of the tray. Note the dark brown discoloration on the tray around the canister. A shadow of the canister is caused by the photographic lights. The cover was installed on the canister housing to protect the space-exposed hardware.

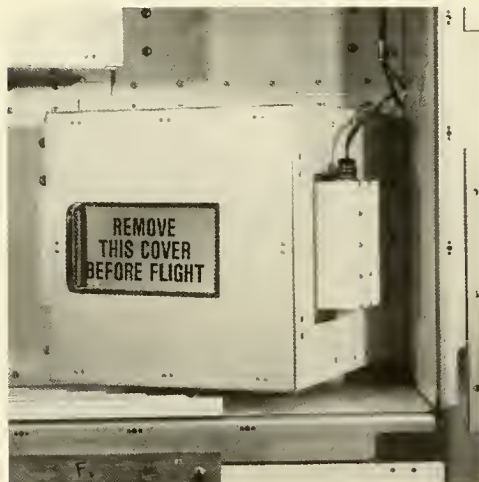
Figure 605
Photo No.: KSC-390C-1637.03
Dup. Neg. No.: L91-I1914
LISAR NO.: EL-1994-00696
Photo Credit: KSC
Photo Date: 3/6/90
Location: KSC SAEF II
Subject: Postflight Detail of Lower Right of Tray H9

Figure 605 (Postflight). This photograph is of the lower right one-fourth of the tray. Note the discoloration on the tray around the canister. Some photographic light shadows are present. The cover was installed on the canister housing to protect the space-exposed hardware.

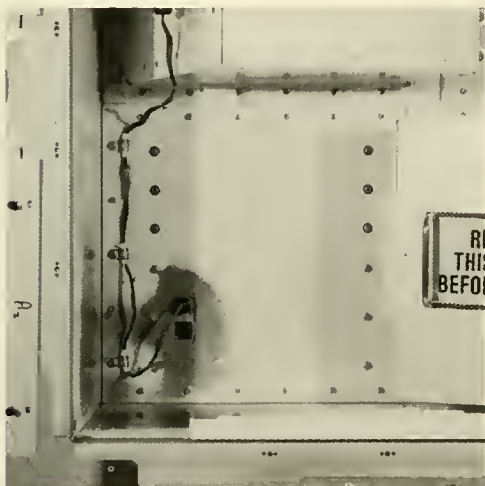
Figure 606 (Postflight). This photograph is of the lower left one-fourth of the tray. Note the extreme brown discoloration on the tray around the grid voltage lead and plug. There are reflections of the lead in the bottom of the tray. The cover was installed on the canister housing to protect the space-exposed hardware.

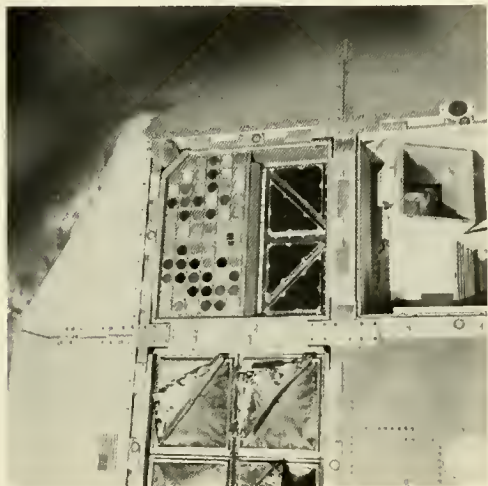
Figure 608
Photo No.: S32-75-060
Dup. Neg. No.: L90-10366
LISAR NO.: EL-1994-00671
Photo Credit: JSC
Photo Date: 1/12/90
Location: In Flight
Subject: In-Flight Survey of Tray H11

Figure 608 (In Flight). There is a brown stain on the tray structure and most aluminum surfaces of experiments. Note the discolorations on the structure of the LDEF, tray flanges, and tray clamp white dots and the variation of discoloration with proximity to the thermal panel vents. The colors in the mirrorlike surface of the detectors are a reflection of the sky and clouds. The dark spot on the detector in the third row from the top seems to be a flaw in the photograph since no damage was found in a postflight inspection.

Figure 610 (Postflight). Both experiments appear intact. The colors in the mirrorlike surface of the detectors are reflections of the surrounding area. A dark spot on a detector in the third row from the top in the in-flight photograph was not found in a postflight inspection.

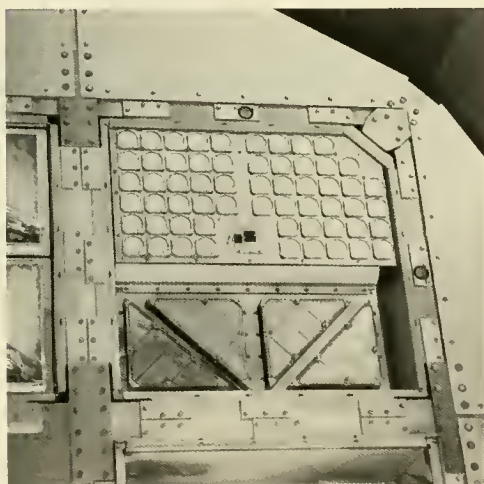
Figure 609
Photo No.: S32(S)-284
Dup. Neg. No.: L92-21191
LISAR NO.: EL-1994-00073
Photo Credit: JSC
Photo Date: 1/22/90
Location: Shuttle Cargo Bay at Dryden
Subject: Postflight Survey of Tray H11

Figure 609 (Postflight). This postlanding photograph was taken from the cargo bay access hatch of the orbiter during postlanding operations at the Dryden Flight Research Center. Note the discolorations on the structure of the LDEF, tray flanges, and tray clamp white dots and the variation of discoloration with proximity to the thermal panel vents. The colors in the mirrorlike surface of the detectors are a reflection of the cargo bay liner of the orbiter.

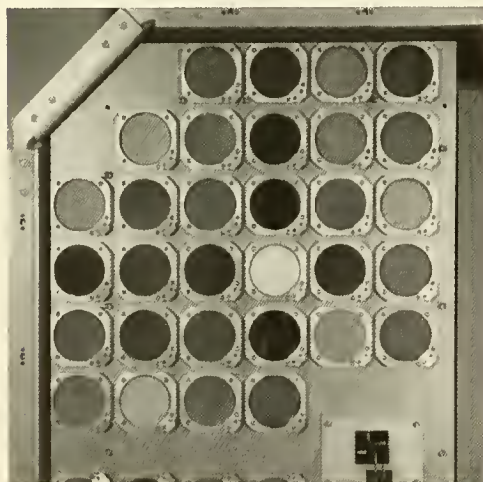
Figure 611
Photo No.: KSC-390C-2065.08
Dup. Neg. No.: L91-15679
LISAR NO.: EL-1994-00464
Photo Credit: KSC
Photo Date: 3/19/90
Location: KSC SAEF II
Subject: Postflight Detail of Upper Left of Tray H11

Figure 611 (Postflight). This photograph is of the upper left one-fourth of the tray. The tray flanges, the sensor holders, and the base mounting plate all have a brown stain. There is a brown stain on the upper right edge of the sensor surfaces. Surroundings are reflected in the mirrorlike surfaces of the detectors.

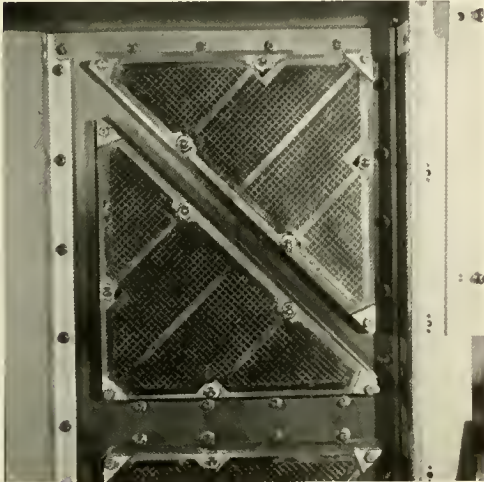
Figure 612
Photo No.: KSC-390C-2065.09
Dup. Neg. No.: L91-15680
LISAR NO.: EL-1994-00465
Photo Credit: KSC
Photo Date: 3/19/90
Location: KSC SAEF II
Subject: Postflight Detail of Upper Right of
Tray H11

Figure 612 (Postflight). This photograph is of the upper right one-fourth of the tray. The die-cast aluminum frames, fasteners, thermal isolation plate, and polished aluminum stop plate are moderately coated with a brown stain. The stain appears more concentrated in vicinities near adhesive bond joints.

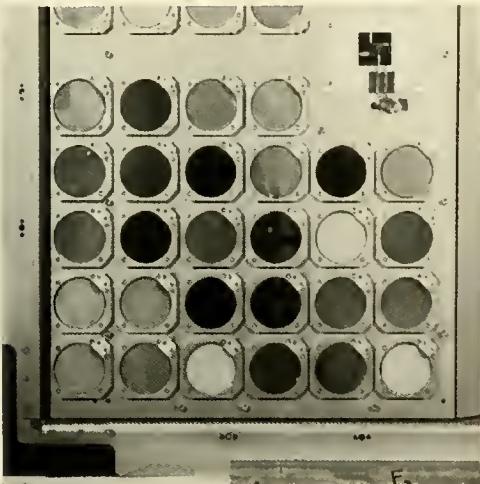
Figure 613
Photo No.: KSC-390C-2065.10
Dup. Neg. No.: L91-15681
LISAR NO.: EL-1994-00466
Photo Credit: KSC
Photo Date: 3/19/90
Location: KSC SAEF II
Subject: Postflight Detail of Lower Left of Tray H11

Figure 613 (Postflight). This photograph is of the lower left one-fourth of the tray. The tray flanges, the sensor holders, and the base mounting plate all have a brown stain. There is a brown stain on the upper right edge of the sensor surfaces. Surroundings are reflected in the mirrorlike surfaces of the detectors.
